MTL TR 90-42

**AIRCRAFT QUALITY HIGH TEMPERATURE  
VACUUM CARBURIZING**

R. J. CUNNINGHAM and R. J. DRAGO  
Boeing Helicopters  
P.O. Box 16858  
Philadelphia, PA 19142

FINAL REPORT

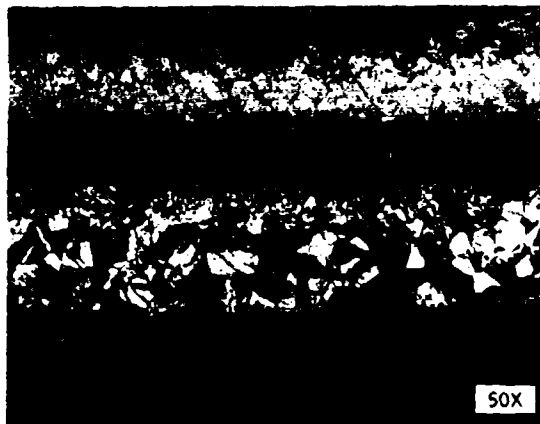
Figure 56. Case microstructure of X2M resulting from vacuum carburization run IV-3
